# Public Roads

Vol. 30, No. 6 February 1959 C. M. Billingsley, Editor

## Progressive Alterations in a Sheet Asphalt Pavement Over a Long Period of Service

BY THE DIVISION OF PHYSICAL RESEARCH BUREAU OF PUBLIC ROADS

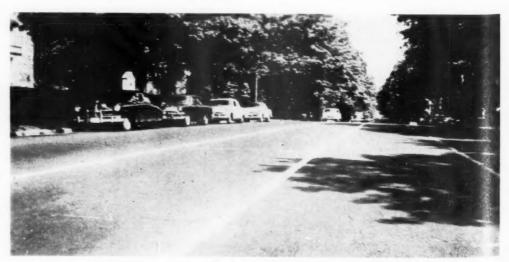
Figure 6.—General view of test area (sections D-1, D-2, and D-3) in April 1955.
